**Incidental Harassment Authorization
Final Marine Mammal Monitoring Report for
August 2015 to August 2016**

**Washington State Department of Transportation
Ferries Division**

**Anacortes Tie-up Slip Project
June 27, 2016**

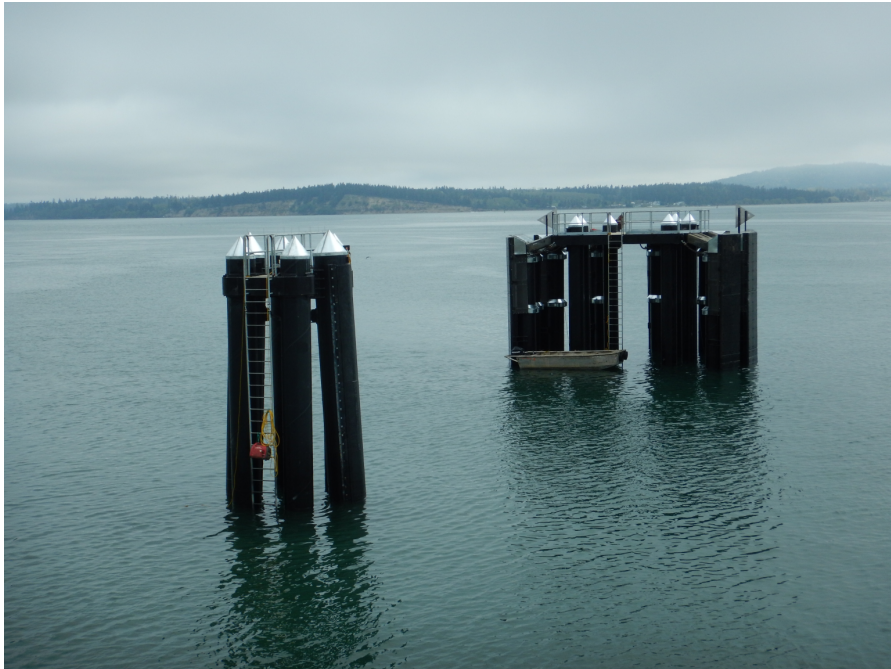
Figure 2-3 Completed Dolphins

temporary pile to act as a guide to protect the ferry vessels during construction. Completed dolphins are shown in Figures 2-3 to 2-6. Approximately 30 tons of creosote-treated timber was removed from the marine environment during this project.
